# Polytron

*Lubrication Technology Based on Micro-Metallurgical Process*

# Polytron Metal Treatment Concentrate (MTC) & Fuel Conditioner (FC)

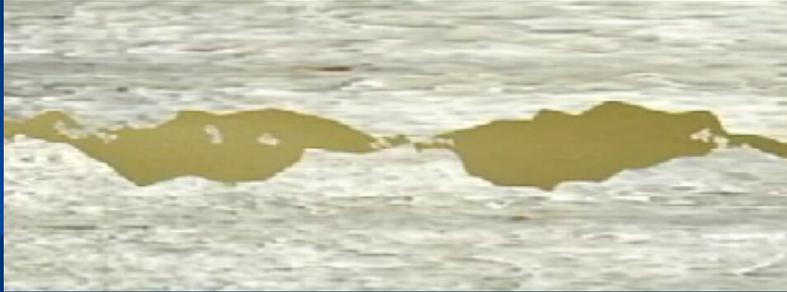
In the heart of this technology is a metallurgical process that allows, under heat and pressure, impregnation of some elements of Polytron, into the crystal structure of metallic friction surfaces, and convert very thin layer on these surfaces into much harder and wear resistant surfaces, resulting with much longer service life, in addition to many other very positive “side effects”.

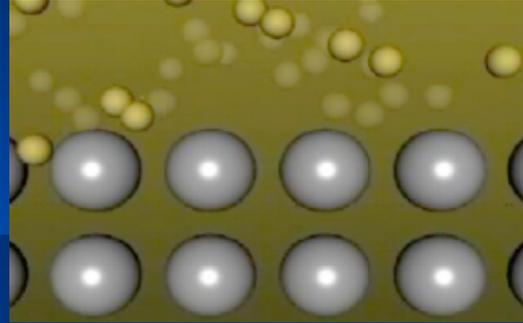
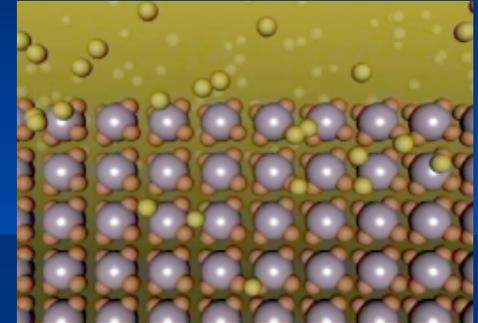
When observing mating friction surfaces under high magnification one can see that they are actually full of “mountains” and “valleys”. These “mountains” penetrate the oil-film that separates mating friction surfaces, and collide with each other. These collisions on the micro level, translate into “friction” between the mating friction surfaces on the macro-level. Some of these collisions result in metal particles breaking away from colliding “mountains”. Breaking away metal particles on the micro-level translate into a “wear” process on the macro-level.

**Conventional lubricants** are based on maintaining high strength and thickness of oil-film in order to separate the friction surfaces from touching each other. In higher pressure, generated by heavy working loads, conventional lubricants introduce an EP (Extreme Pressure) protective deposit between moving mating surfaces in order to replace the oil layer squeezed out by pressure. This way, they try to resist failure from scoring, seizure or accelerated wear. The conventional lubricants succeed in their task only partially, so a continuous wear process still takes place, contributing to deterioration in performance. This in turn, plays a significant role in the vicious cycle of deterioration in performance accelerated wear, etc.

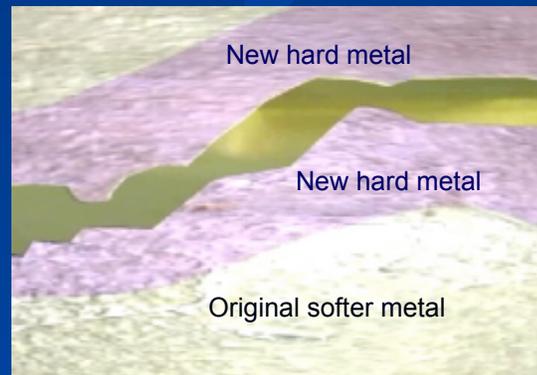
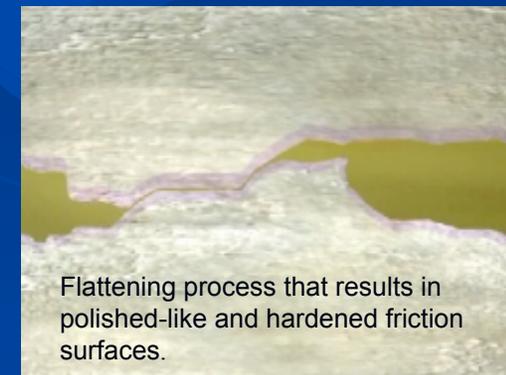
Because active elements of Polytron are polarized, when Polytron is applied, they are attracted to the metal. Under heat and pressure these polarized elements metallurgically impregnate the metal's crystal structure on its mating friction surfaces.

Flattening process that results in polished-like and hardened friction surfaces.

As a result of the metallurgical process, a very thin layer of original metal is converted into a new type of metal that is much harder and has a wear life that is **at least 15 times longer than the original metal**. This newly formed layer of metal protects the original “softer” metal beneath it from wear.

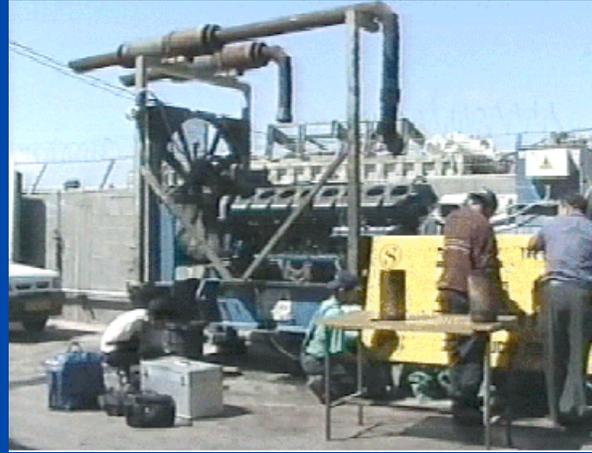
1000 KVA Cummins Generator driven by 1,800 horse power engine was in service for more than 30,000 hours And was taken apart because of presence of water in oil for more than 100 work hours.

The engine was put together without replacing or machining any parts. According to our most conservative estimate, over 30,000 hours that the generator was in operation, the user saved at least \$150,000 on repairs, fuel and oil consumption. And spent only \$7,690 on Polytron products, a return of approximately \$20 on each dollar invested in Polytron

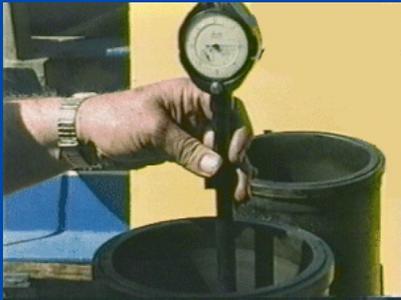
There was almost no wear on the liners and the dimensions were within the manufacturer's specs.

They looked polished and still had their cross honing pattern of the original bore

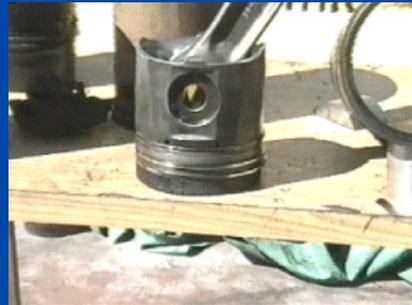
All the pistons had piston skirts and piston rings totally clean of any build-up. The rings looked like new and didn't have any wear.

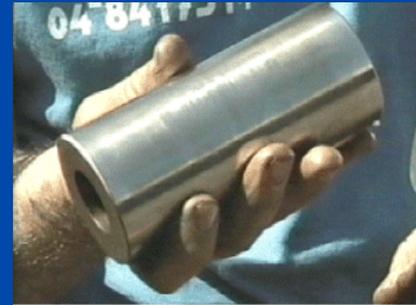
After 30,000 hours in operation and 100 hours in the presence of water, all the piston pins didn't have any traces of wear, looked polished-like and new.

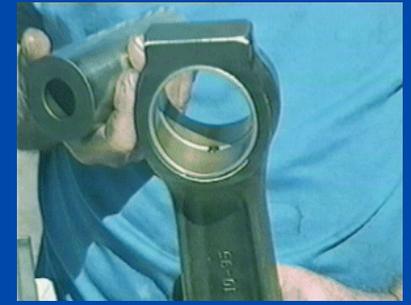
After 30,000 hours in operation and 100 hours in the presence of water, all piston pin bearings didn't have any wear and looked like new.

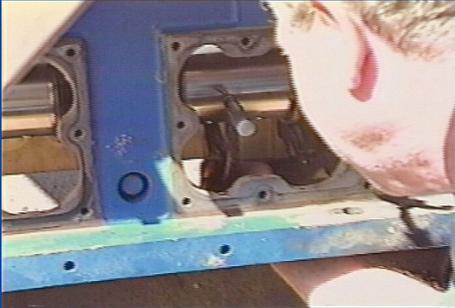
We micro-measured the crankshaft and found it to be in great condition. Totally round, no traces of wear. It didn't need any machining.

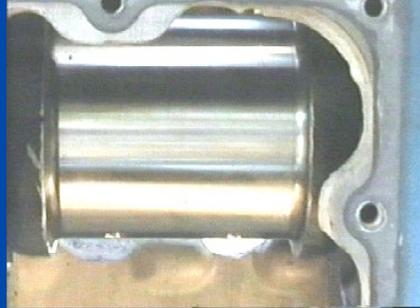
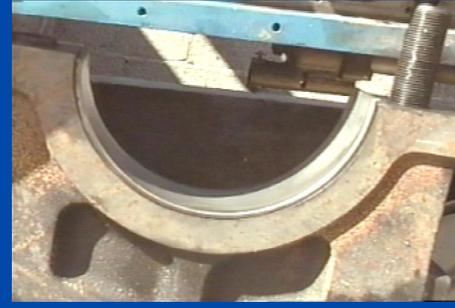
Crankshaft Main Bearings looked like new, there were no traces of wear. They maintained their original coating. Usually after 17,000 hours they are chewed up. In this engine we used **Polytron**, so there was almost no wear at all after 30,000 work-hours.

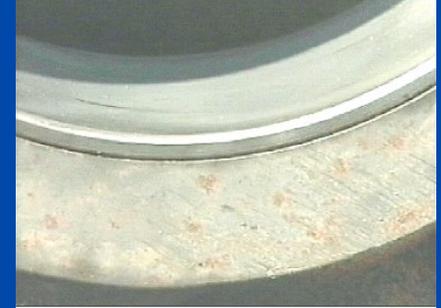
Piston-rod bearing from 16,000 hours old engine, (without **Polytron MTC**) chewed up as a result of wear.

Piston-rod bearing from 16,000 hours old engine, (without **Polytron MTC**) chewed up as a result of wear

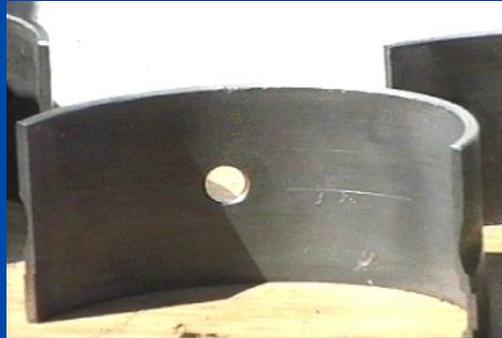
Piston-rod bearing from our 30,000 hours old engine with **Polytron MTC** totally clean with almost no wear at all.

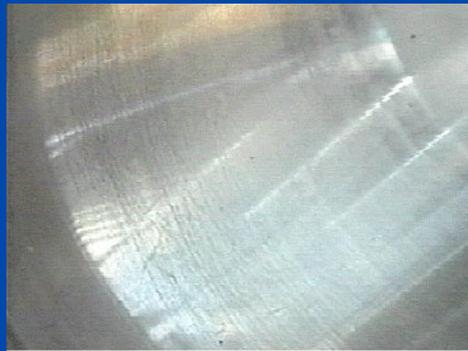
Cylinder liner from our 30,000 hours old engine with **Polytron MTC** totally clean with almost no wear at all.

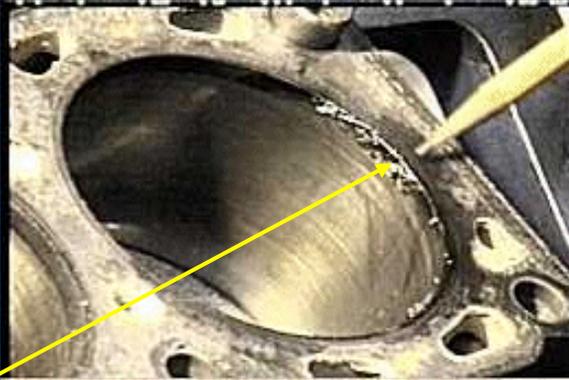
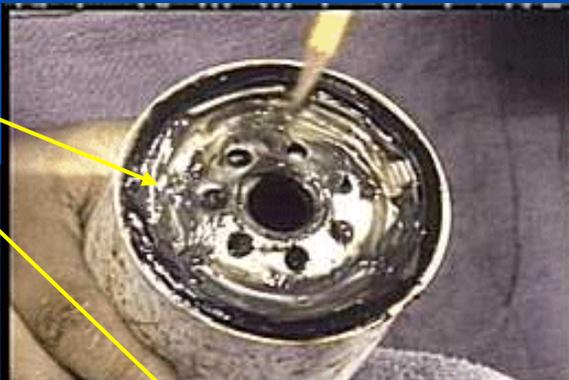
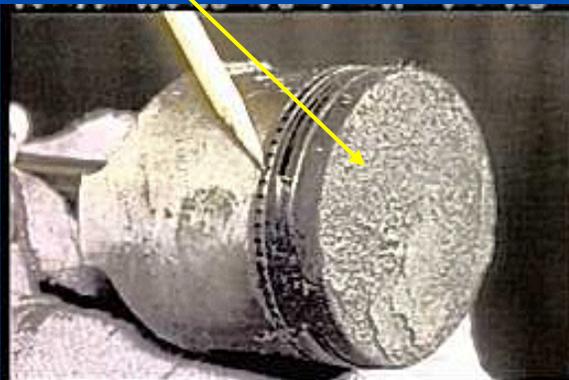
## Not Treated

Sludge and Carbon build-up

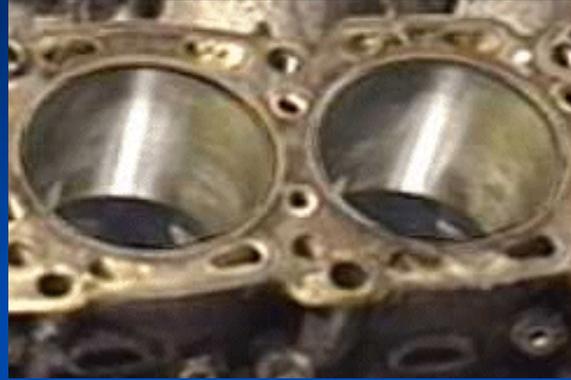
Cylinder walls are always clean

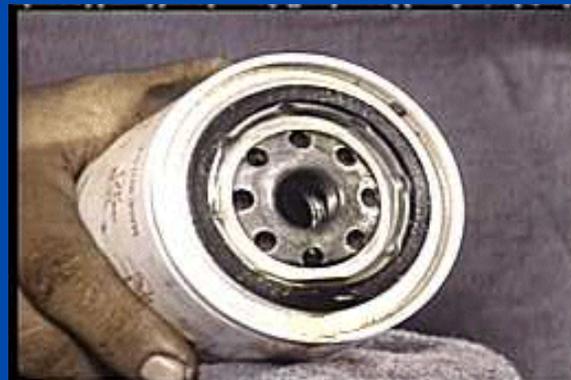
Oil filters are clean

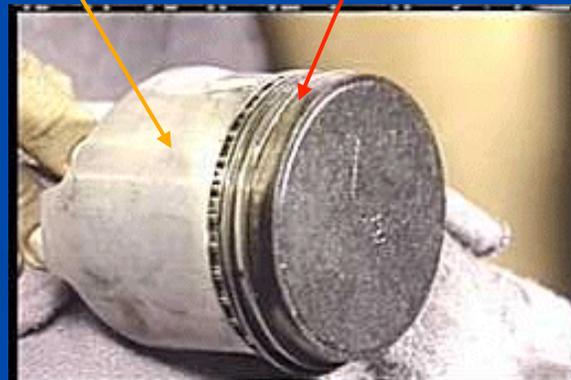
As a result of using Polytron MTC, and FC the piston-skirt (orange arrow) and rings (red arrow) are totally clean of any deposits

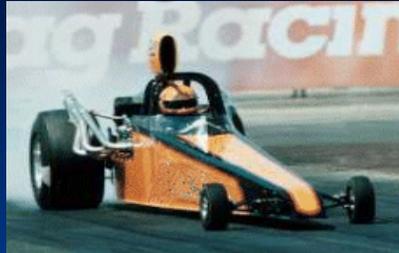
The piston on the left was taken out from a Dragster engine after 70 runs without Polytron MTC.

The piston skirt has a severe scuffing

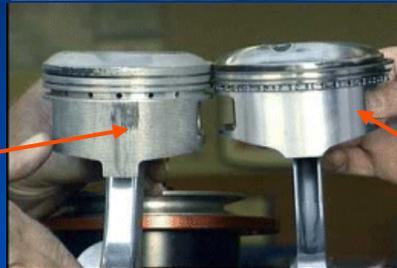
The piston on the right was taken out from an engine after 350 runs with Polytron MTC. The piston has no signs of wear, is totally clean, and all the friction surfaces are polished.

Before Polytron MTC was used, the engine was always taken apart for repairs after 70 runs. After Polytron MTC was applied, the engine was taken apart after 350 runs. As you can see, the engine parts have almost no wear and are totally clean. There is carbon buildup on the first piston ring (since Polytron FC is not used) but there is no carbon buildup on the other rings, and the ring surfaces are polished and clean and the cylinder skirt is totally clean. In addition there is almost no wear on the piston rings.

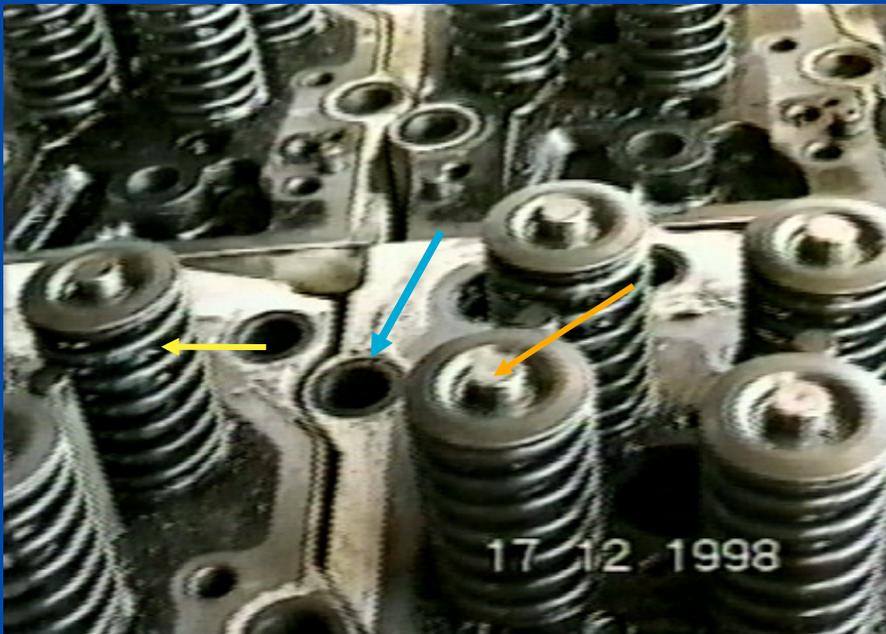
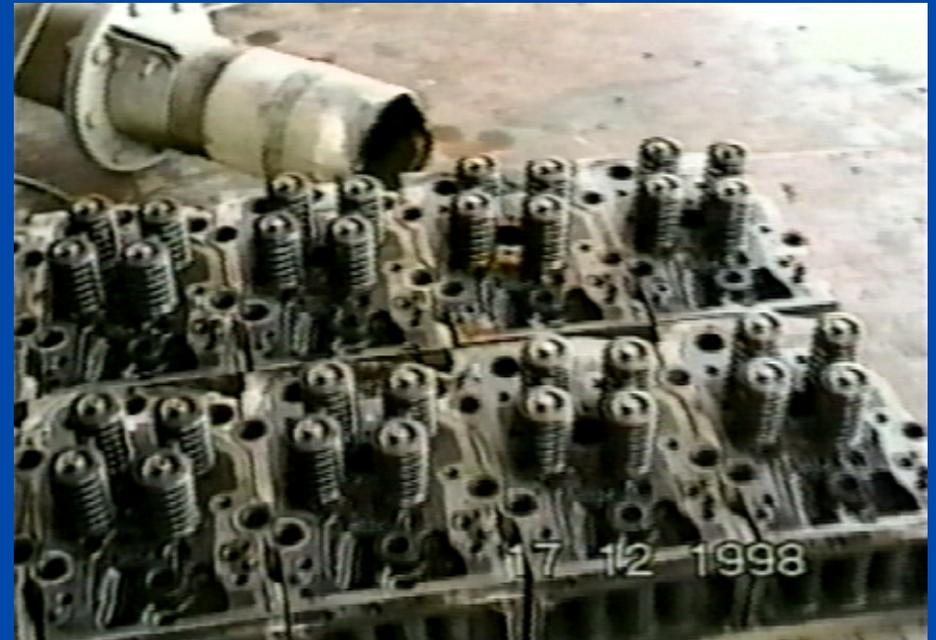
## Engine head block

This engine (in which Polytron MTC was used) has been taken apart after 17,500 work-hours as a result of penetration of water into an oil system. The oil baths (blue arrow), valve springs (yellow arrow), valve stems (orange arrow) and the block surface are totally clean of any deposit build-up. According to the head mechanic of the repair shop, he has never seen anything like this before, especially with oil change intervals 4 time longer (from 250 work hours to 1000 work hours) and after many work hours with water in the oil system. All the other engine parts also were found to be in very good condition, and were put right back when the engine was re-assembled.

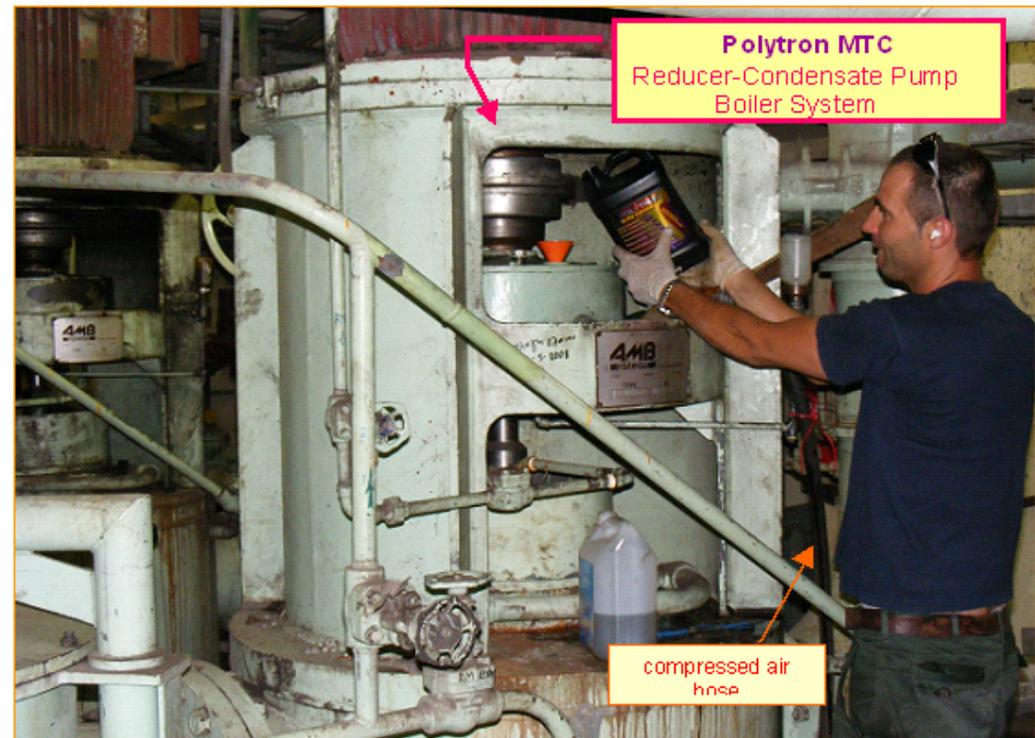
The temperature dropped by 4 to 5 °C and pump was not overheating anymore and the air compressor was not used for cooling anymore.

- Pump Alarm Temperature : 56°C
- Pump Trip Temperature : 65°C
- Temperature prior to Polytron with compressed air cooling the pump : 55°C - 62°C
- Temperature after Polytron without compressed air cooling the pump : 52°C - 56°C
- Ambient Temperature : 35°C - 40°C
